# MULTIVIZ VIBRATION

Early detection of  
gearbox failure

# DETECTING FAILURE 2 MONTHS IN ADVANCE

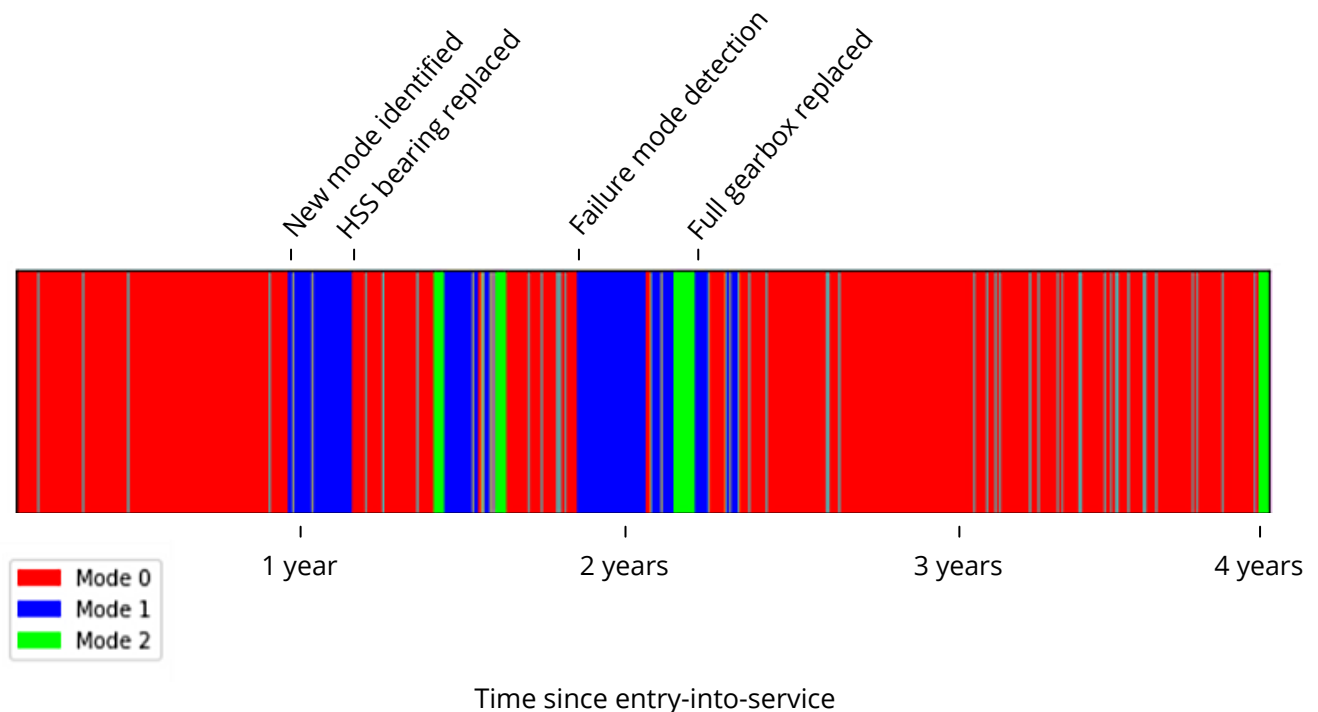
MultiViz Vibration first detected an operational mode at the beginning of the life of the machine, identified as a normal operational mode. However, after 11 months, a new operational mode emerged, lasting for three months. The new mode was caused by a high-speed shaft bearing fault, which had only been caught by

The bearing was replaced, and the machine immediately went back to the initial normal operating mode. Some months later, the same failure mode is again identified, as the problem from the high-speed shaft bearing extended to

the other components of the gearbox, affecting its operations and demanding the replacement of the entire equipment.

The image shows all the modes identified in the gearbox, the blue one being the failure mode. Grey represent areas with uncertainty around its mode assignment.
