# MULTIVIZ VIBRATION

Detecting atypical  
assets in a wind farm

# DETECTING ATYPICAL ASSETS IN A WIND FARM

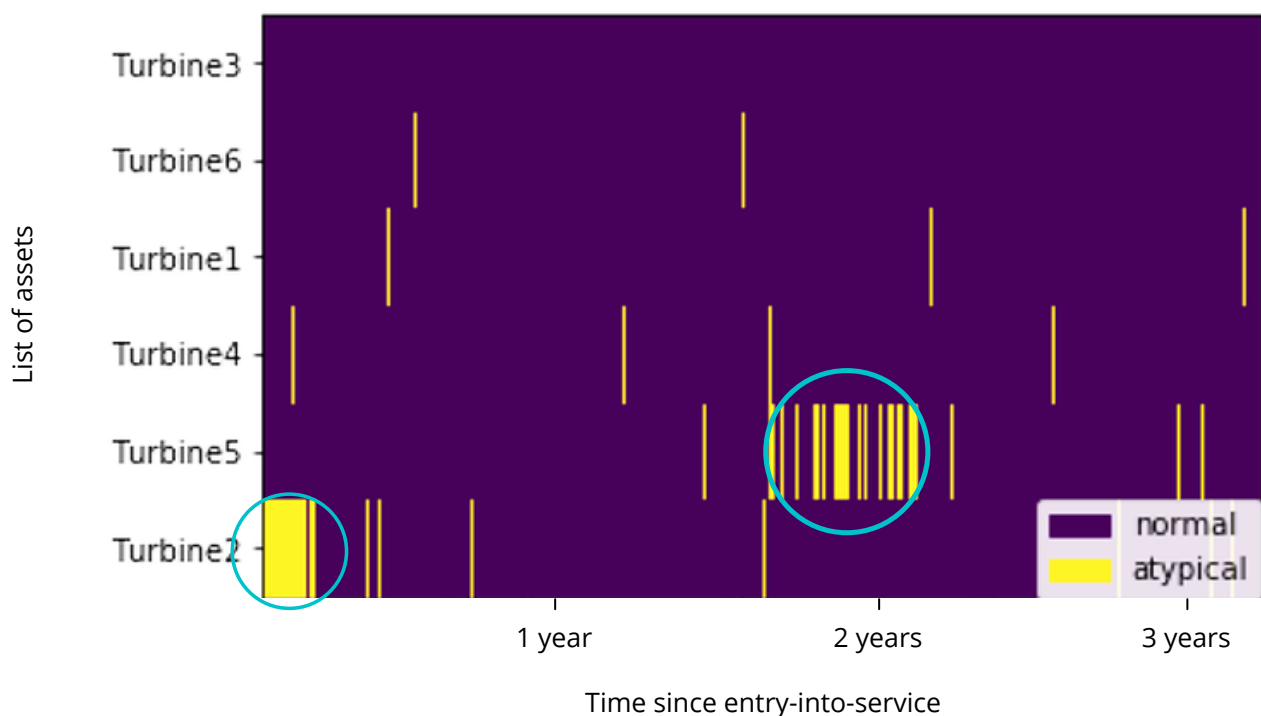
The image shows the analysis of the entire population of assets in the wind farm, as well as their detected modes. The circled areas indicate the faulty periods.

MultiViz Vibration identified that two wind turbines out of six were the most atypical, Turbine2 and Turbine5. While Turbine2 was most atypical during entry-into-service, Turbine 5 displayed a failure for a longer time.

The behavior in **Turbine2** was caused by a minor electrical issue affecting the sensor recording the vibration signal. MultiViz Vibration was able to detect the problem even in data that would normally be considered healthy, as the turbine had just entered operation.

**Turbine5** displays a major failure during the entire recorded time. After 1.2 years of operation, the high-speed shaft bearing had to be replaced due to an inner raceway failure.

However, after this replacement, the failure had already propagated through the entire gearbox, which had to be replaced after approximately 2 years of operation. After this, the turbine got into a healthy condition.
